**DEPARTMENT OF TRANSPORTATION**

Contract #: 04-0120F4Cty: SF/ALA Rte: 80 PM: 13.2/13.9File #: 69.28**WELDING INSPECTION REPORT****Resident Engineer:**Siegenthaler, Peter**Address:** 333 Burma Road**City:** Oakland, CA 94607**Report No:** WIR-024679**Date Inspected:** 18-Jun-2011**Project Name:** SAS Superstructure**OSM Arrival Time:** 700**Prime Contractor:** American Bridge/Fluor Enterprises, a JV**OSM Departure Time:** 1900**Contractor:** Zhenhua Port Machinery Company, Ltd (ZPMC), Changxing Island **Location:** Shanghai, China

**Bridge No:** 34-0006**Component:** Orthotropic Box Girder( OBG)**Summary of Items Observed:**

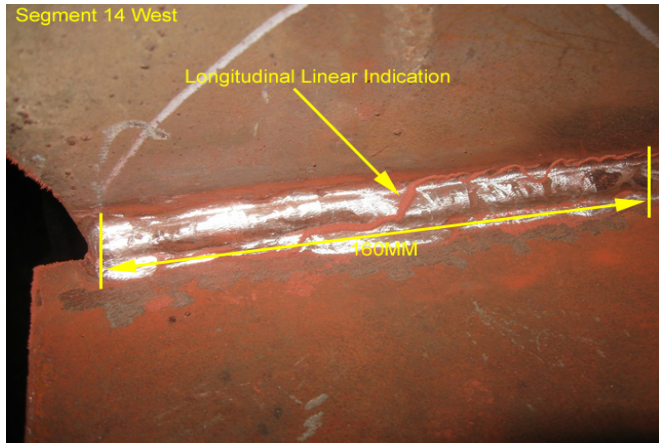
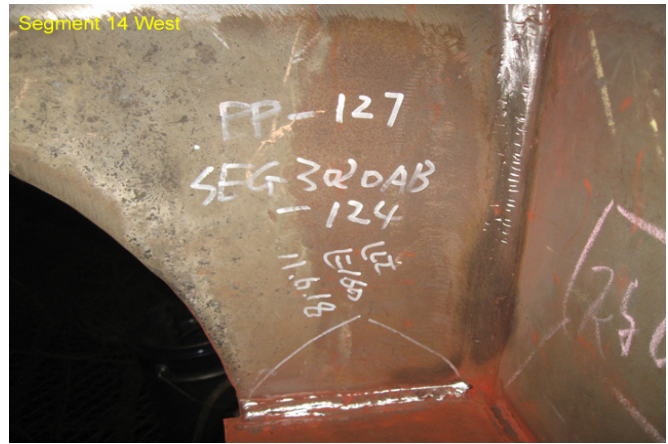
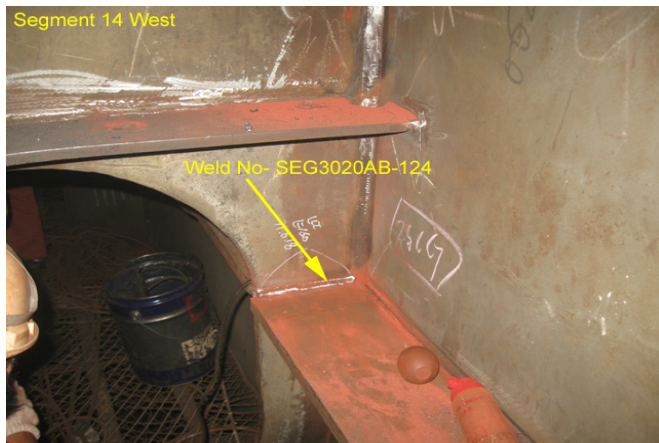
During random witness of weld joints is identified as SEG3020AB-124 this QA observed Longitudinal Linear Indication on the welds. This QA along with ABF QA MT Technicians marked the affected areas and informed ZPMC Quality Control (QC) CWI indentified as Mr. An Qing Xiang of this issue. Mr. An Qing Xiang informed this QA that the cracks would be corrected in a manner compliant with the contract documents. This QA Inspector also informed to Lead QA Inspector of the issue. See attached photos for further details.
